Leacraithnaich Bothy : A Renovation and a Roof Renewal

Leacraithneach : A New Lease of Life for an Old Friend

From MBA Newsletter No. 208, Summer 2019

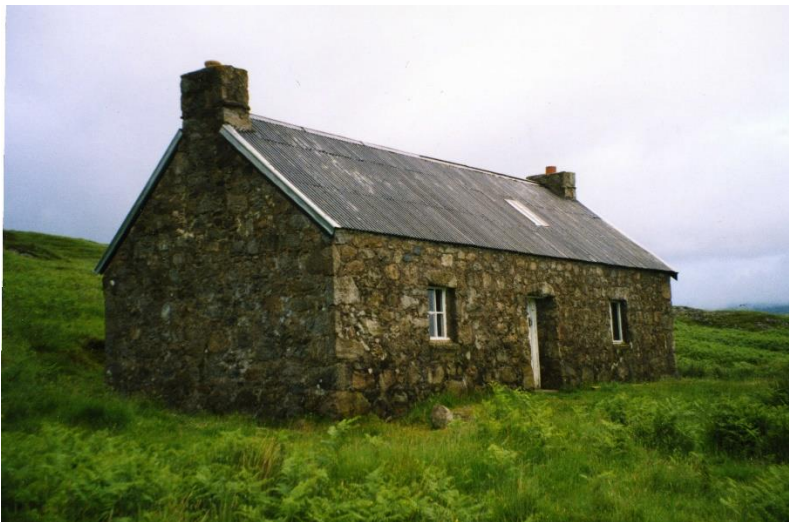
The bothy in April 1983 : More usable than most before renovation

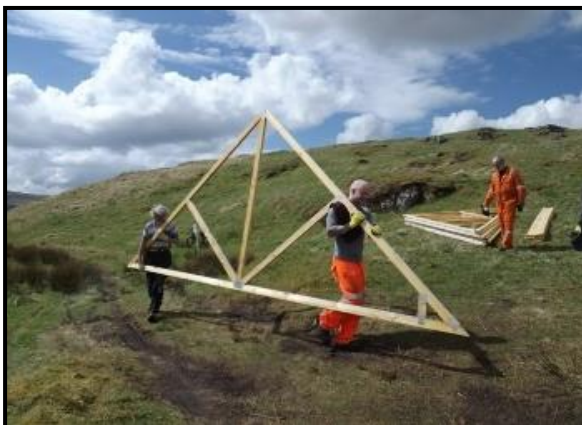
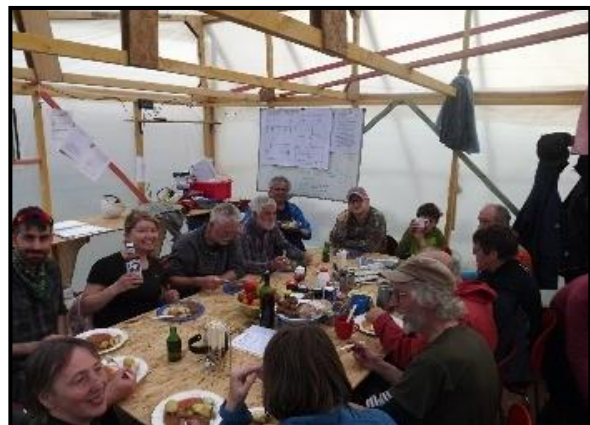
The canteen

Our canteen was built as a 4.8m base with full-length work surfaces on two sides for the cooks' use. We installed a sink in one of the sides and a microwave cooker was available on the other when needed. Photovoltaic (PV) lighting was provided over the work area if needed. The dining table was a 1.2m x 2.4m OS board, loosely resting on the existing bothy table. Seating 17 people around it was a challenge, however the lesser numbers that were the norm could be accommodated more easily. A separate drinks table was a must on a project like this!

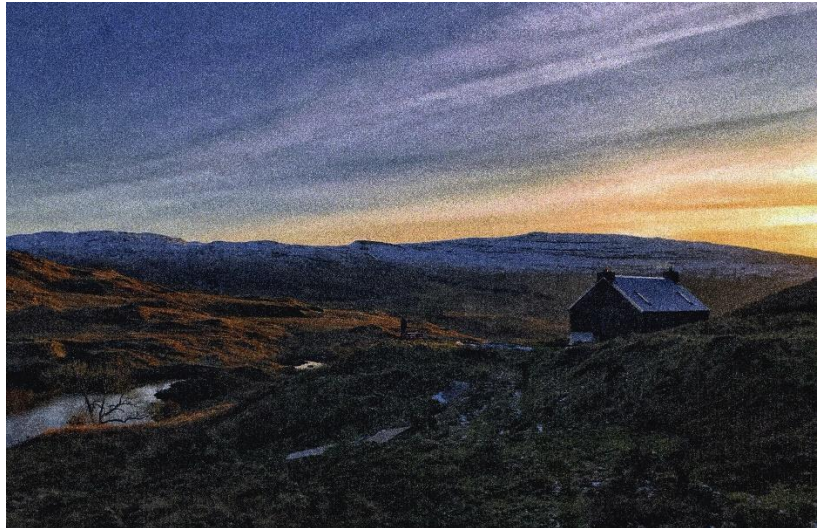
Leacraithneach reroofed and dramatic skyscape,
from MBA 2021 calendar by Kirsty Hamilton
